FIELD UPGRADE INSTRUCTIONS

SCREW TORQUES

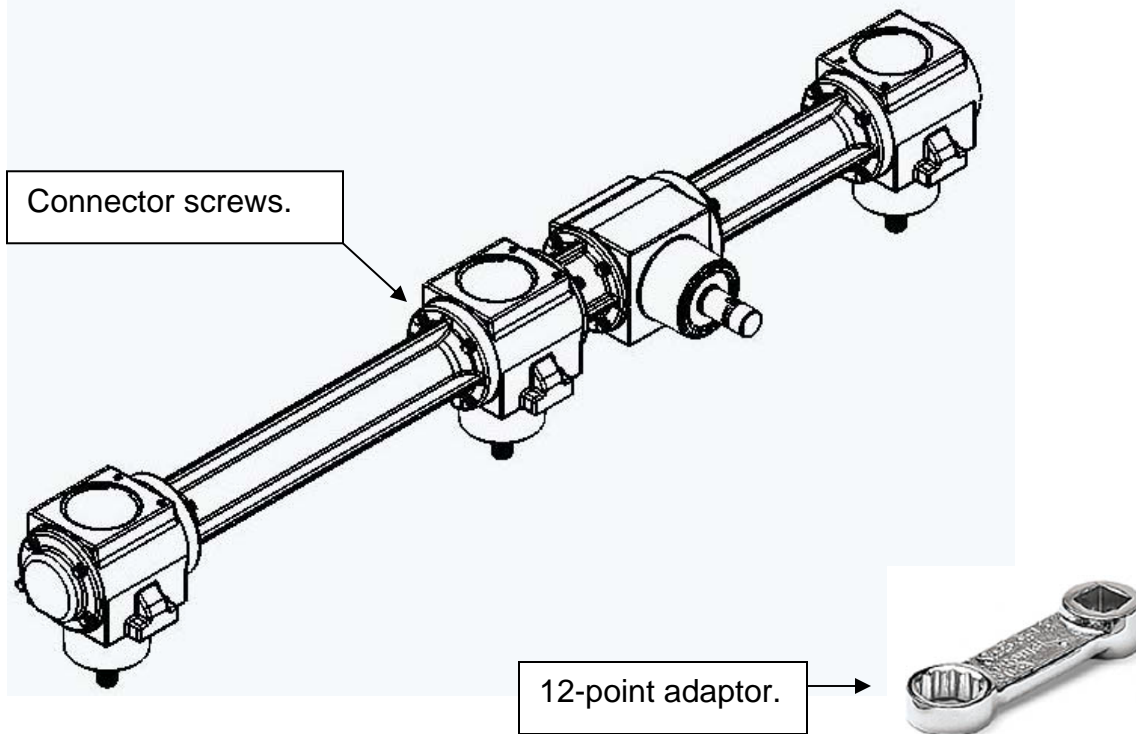
CONNECTING TUBE SCREWS:

It is believed that external variables from mowing operations such as deck flex, vibration, blade shaft loading, etc. can reach levels of input onto the gearbox assembly which could cause premature failure. It appears that one factor alone may not be significant enough to cause a failure. However, a culmination of these factors can add enough stress or flex to the assembly and its internal components leading to component failures. It has been identified that Von Ruden assemblies built prior to 10/01/02 require increased strength in support. Those assemblies can be upgraded by increasing torques on assembly screws. All assemblies built after 10/01/02 are at this increased torque requirement.

1. Remove one 12-point screw at a time and apply LOCTITE® 262 or 277 (or equivalent) to the threads and reinstall. We recommend use of 5/16" 12-point torque adaptor (Snap-On® PN FRDH101). Torque to 260-300 lb.-in. (29-34 N-m). Do not torque screws beyond this maximum specification, keeping in mind the repeatability of your torque wrench. Assembly removal from deck may be required.
2. Repeat process until all screws have been processed. Alternate screws in a cross-hatch pattern.
